## IMPLANT PARTS GRAPHITE CLEAN

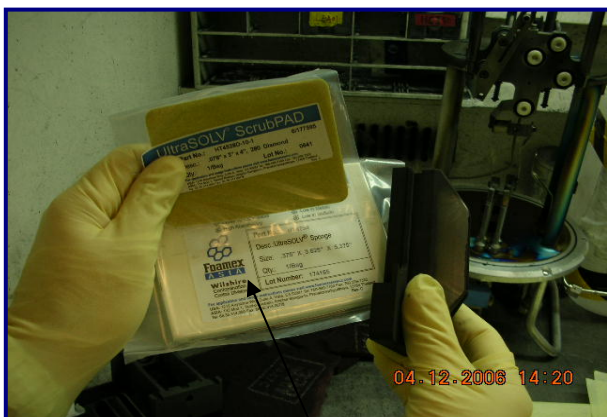
#### **PARTS NEEDED TO CLEAN IMPLANT GRAPHITE PARTS**

- 280D GRIT DIAMOND SCRUBPAD
- ULTRASOLV® SPONGE

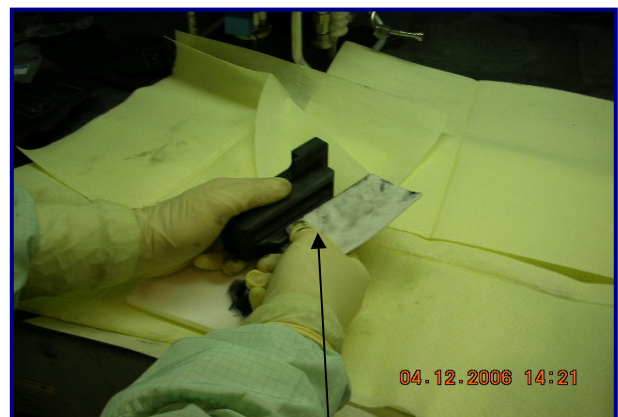
#### **CLEANING GRAPHITE PART WITH DIAMOND SCRUBPAD**
