## IMPLANT PARTS GRAPHITE CLEAN

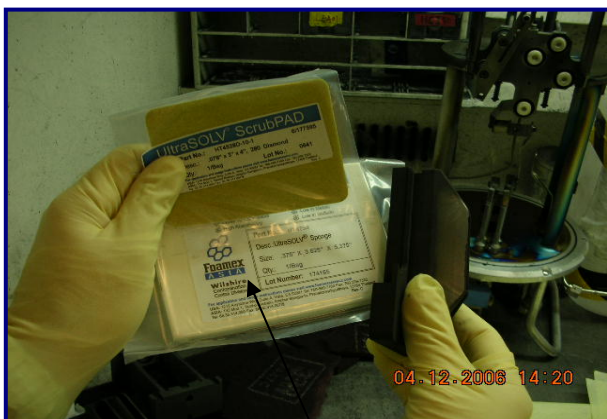
#### **PARTS NEEDED TO CLEAN IMPLANT GRAPHITE PARTS**

- 280D GRIT DIAMOND SCRUBPAD
- ULTRASOLV<sup>®</sup> SPONGE

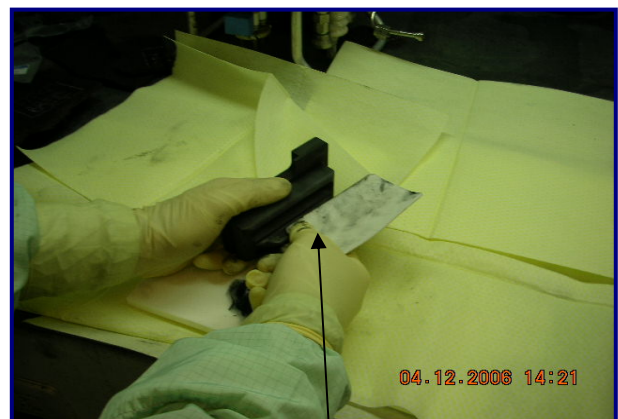
#### **CLEANING GRAPHITE PART WITH DIAMOND SCRUBPAD**

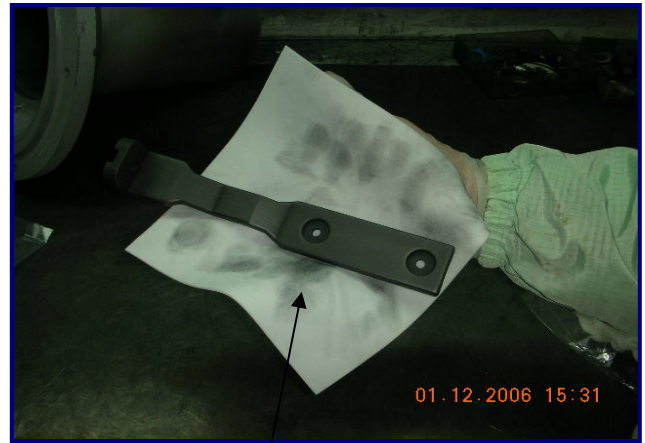
**GRAPHITE PIECE WIPED WITH ULTRASOLV® FOAM WIPER AFTER BEING WIPED WITH STANDARD FAB WIPER**

- MUCH MORE PARTICLES REMOVED WITH ULTRASOLV® FOAM WIPE
